IMPROVED TRANSITION RAMPS FOR
McMURDO STATION, ANTARCTICA

Technical Note N-1317

NAVAL CIVIL ENGINEERING LABORATORY
Port Hueneme, California 93043

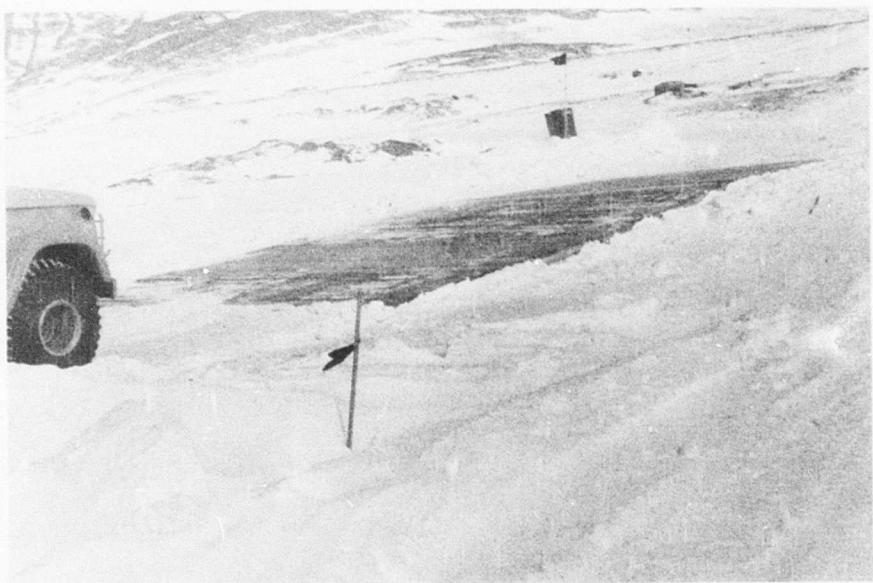
During DF-68, the Naval Civil Engineering Laboratory (NCEL) fabricated and installed a 32-foot long timber ramp (Figure 3) over the tide crack at the transition from sea ice to land on the Pass Road between McMurdo Station and Williams Field (Figure 1). The ramp was fabricated with 16-foot long, 6x6 stringers covered with 2x6 decking. The experimental timber ramp, which was tested under NCEL Work Unit YF 53.536.001.01.002, "Vehicle Road Systems on Snow and Ice," improved trafficability, but only slightly. The major shortcoming of the experimental ramp was its limited length. It was also time consuming to construct and required frequent repair.

Figure 3. Timber ramp constructed during DF-68 at sea ice to land transition.

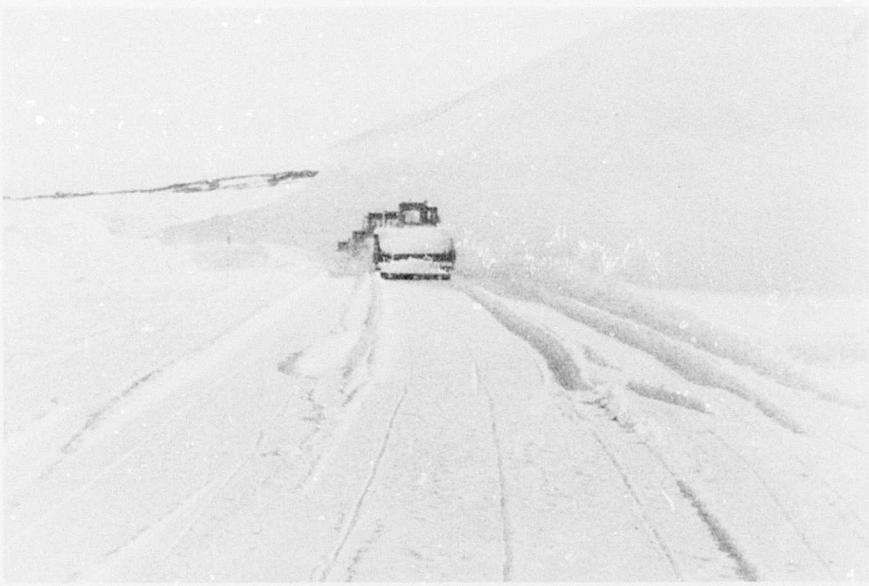
At the present time, the end of the earth overlay is adjacent to a cliff which shades about 300 feet of adjacent roadway several hours each day (Figure 5). The shade reduces exposure to solar radiation and decreases deterioration of the snow road. Extension of the earth overlay past its present location will increase deterioration of the snow road and impede vehicular traffic.

Figure 5. Shaded section of snow road near Scott Base.

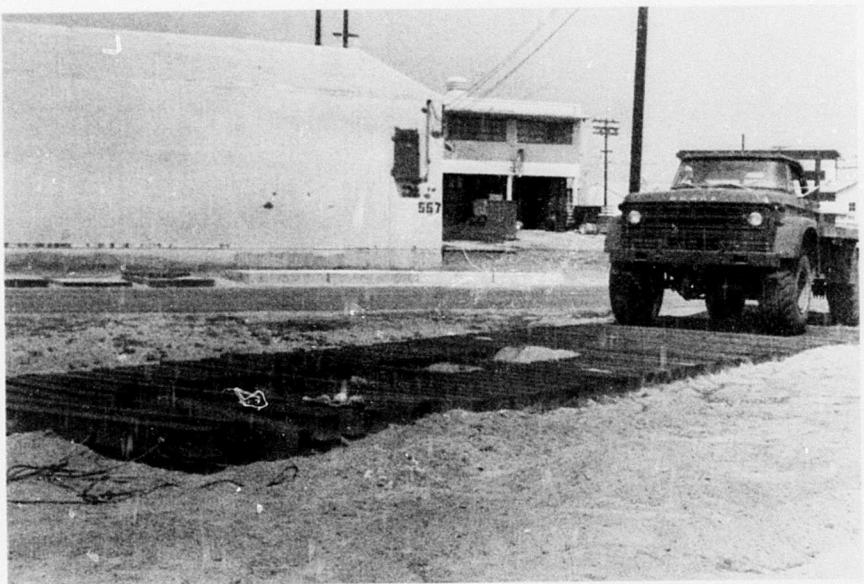
A Dodge W-500 equipped with 19.75x20 high-flotation tires was used to traverse the prototype ramp fifty to sixty times (Figure 7). Observations were made to determine the effects of traffic on the durability of the two test sections. When placed on a hard, level road, the Dodge W-500 caused very little movement in the ramp and no damage. However, when placed on beach sand, the timbers in both test sections twisted as the Dodge W-500 traversed the ramp. As the timbers twisted, the pipe spacers cut into the wood. After only a few passes with the Dodge W-500, each timber had a hole worn at each spacer. Inspection of the prototype ramp indicated that except for wear around the pipe spacers, the performance of both test sections was satisfactory.

Figure 7. Dodge W-500 traversing prototype timber ramp on beach sand.

It was concluded from these tests that a flexible timber ramp configured similar to test section B, except with wood spacers instead of pipe spacers, would be tested at McMurdo Station.

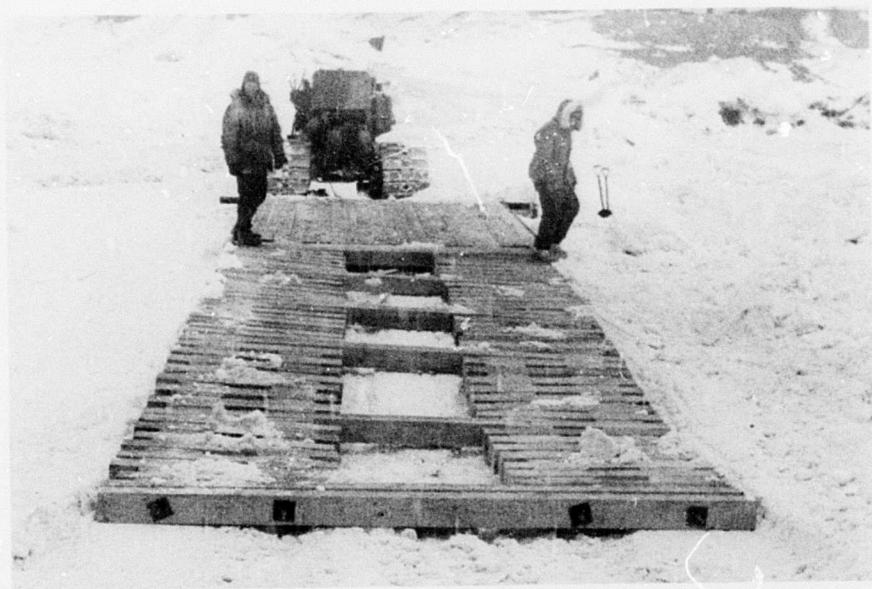
Figure 9. Timber test sections being moved into place.
